KICK-OFF MEETING /

- **OWNER / Satsop Capital Projects Committee**
- OWNER'S REPRESENTATIVE / Rock Project Management Services
 - **ARCHITECT /** Bassetti Architects
 - CIVIL ENGINEER / AHBL
 - STRUCTURAL ENGINEER / PCS Structural Solutions
 - MECHANICAL ENGINEER / Tres West Engineers
 - **ELECTRICAL ENGINEER / TFWB Engineers**

KICK-OFF MEETING / SITE INVESTIGATION FINDINGS

TWO-ROOM SCHOOLHOUSE (1902)

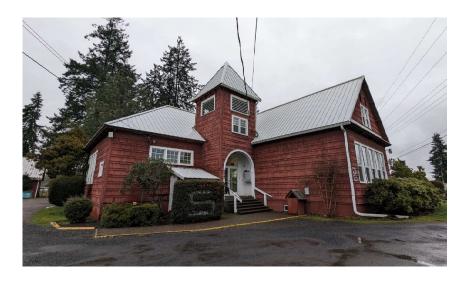
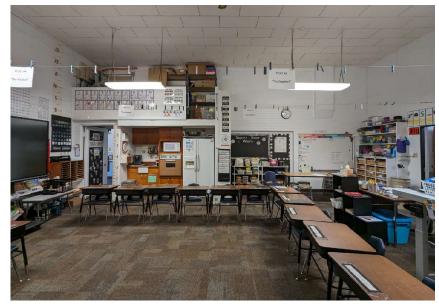
MAIN BUILDING

- + Improve Student Restrooms
- + Improve Exterior Finishes
 - Wood skirting and siding
 - Paint exterior
- + Improve Lighting
- + Renovate North End of Building
 - Bigger office or SPED room
 - Relocate teacher kitchen from classroom
 - Improve teacher restroom
- + Increase Storage in Classrooms
- + Improve Attic / Bell Tower Access

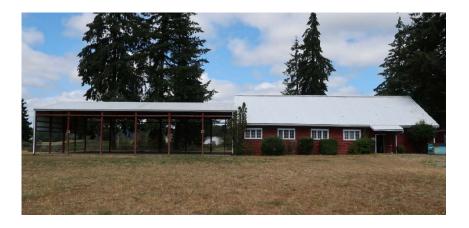
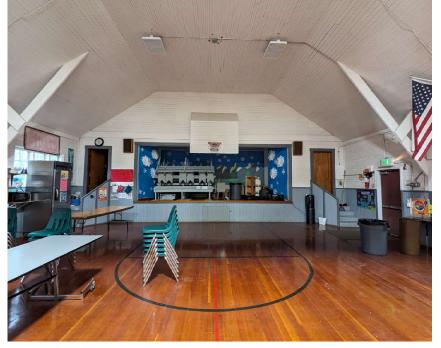
GYM/DINING BUILDING / COVERED PLAY

- + Enclose the Covered Play Area
- + Add New ADA-compliant Restrooms
- + Add New Kitchenette
- + Add New Storage
 - Equipment storage, furniture storage
- + Upgrade Furniture
 - Gym bleachers
 - Lunchroom seating & tables
- + Reconstruct stage for access and increased usable storage
- + Improve Lighting

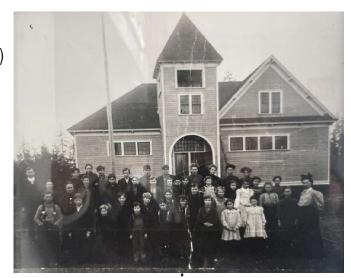
- + Simple, Functional Design (rectangular, symmetrical layout)
- + Wood Frame Construction with Gable Roofs
- + Wood Siding for Exterior Wall Finishes (cedar shakes)
- + Wood Paneling for Interior Wall Finishes
- + Wood Floors and High Ceilings
- + Bell Tower

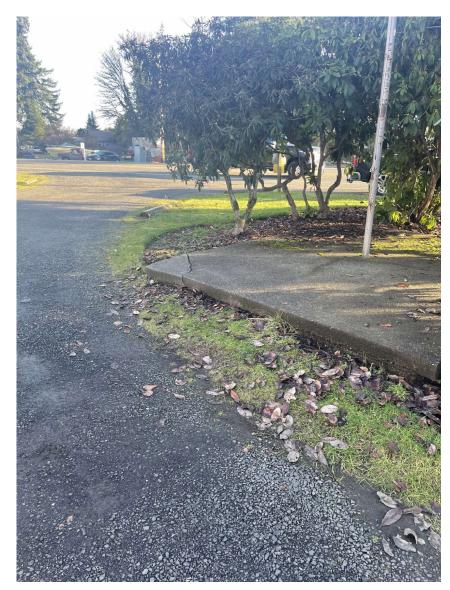
- + There are high points at the baseball field and the road with a low spot in the middle.
 - Recommendation: Regrade would be the best option, but a swale with finger drains could be designed to address most of the draining issues.
- + There are additional spots of poor drainage around the main building which are impacting the building siding.
 - Recommendation: Local grading maintenance around building.
- + The flagpole pad will need to be cut back to accommodate the new driveway but should not need to move.
- + AHBL to do research on the well logs. Information on the cover was illegible due to paint.

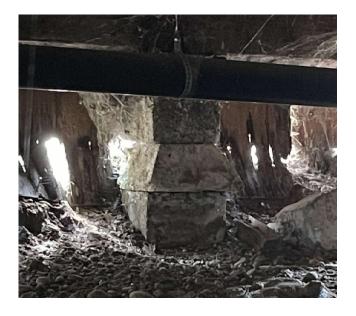
- + Cripple wall construction at perimeter walls.
 - Recommendation: Provide 6" concrete stem wall around the perimeter of the building.
- + No real seismic concerns from the floor up.
- + Noted deterioration of the perimeter skirting and 50% or more of the posts.
 - Recommendation: Redo perimeter skirting and the deteriorated posts.
- + New beams would be required at locations where main interior walls are removed.
- + Two chimneys have been removed above the roof, but still exist in the attic and at main floor level. Chimney between Classrooms 2 & 3 terminates above the floor by several feet.
 - Recommendation: Remove chimneys down to the ceiling and full extent at classrooms.

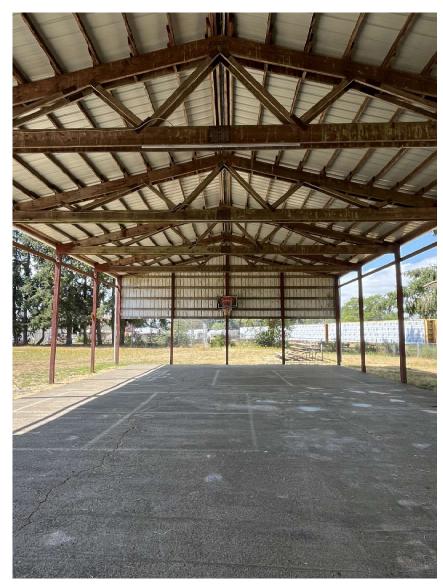
- + Cripple wall construction at perimeter walls.
 - Recommendation: Provide 6" concrete stem wall around the perimeter of the building.
- + No real seismic concerns from the floor up.
- + At Covered Play, scope will need to consider if the existing roof structure is to remain or be constructed as new.
 - If the existing roof and columns are maintained, the new walls will act as lateral bracing for the new structure.
- + At Covered Play, new plywood may be required at underside of joists.

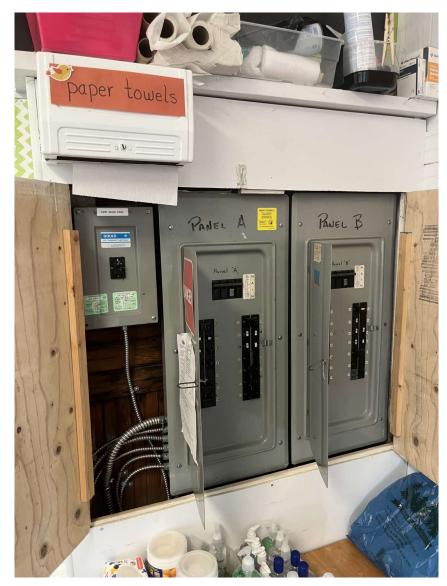
- + Main building served by residential service. No 3-phase service.
 - Recommendation: Upgrade to 3-phase service and feed the gym building off of the main. Or, separate the gym building on it's own service.
- + Gym is currently on overhead service from main building and there is no additional capacity available
 - Recommendation: Separate the gym building on it's own service.
- + Currently no fire alarm or intercom system.
- + Covered Play lighting was upgraded in 2019 but the gym and main building have older fixtures.
